MCI SERVICE LETTER #6

# SERVICE BULLETIN

PRODUCT JH-16

BULLETIN NO. 103

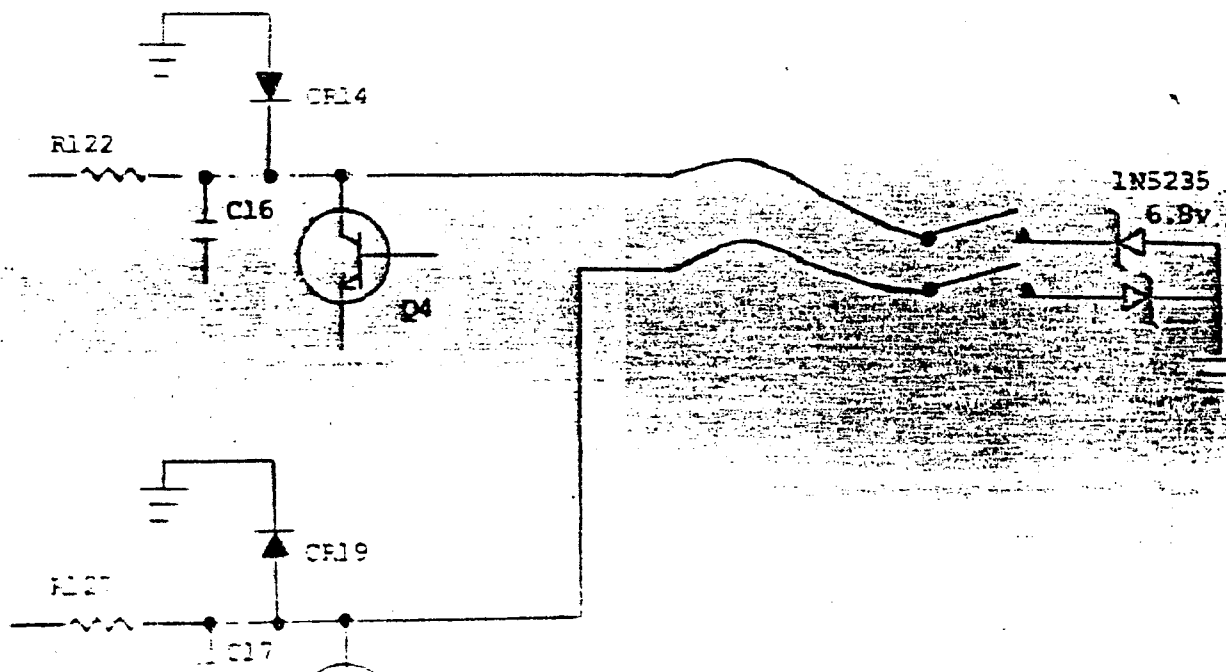
When thin tapes are used on JH-100 transports, the tension can be great enough to stretch the tape. If the customer has this problem, limit the torque by adding the components described below.

Diodes CR14 and CR15 must be shunted by 6.8v zeners (1N5235) to limit the back-bias voltage. The zeners must have the same polarity as the diodes:

NOTE: CR19 on schematic is labeled CR17 on the board

If the machine is to be used for BOTH thin tapes and regular tapes, a DPST switch should be installed as follows:

Mount a mini-toggle switch in one of the vent slots in the transport electronics chassis. Connect as follows:

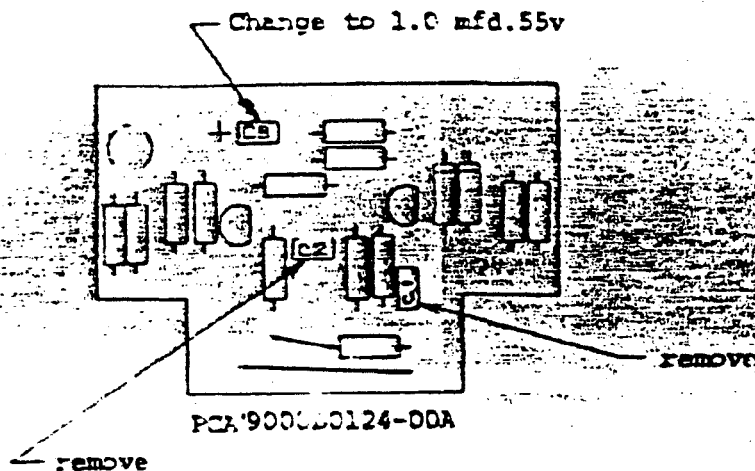
**REASON FOR CHANGE:** Complaints from the field point out that the PET Cards which replace the mechanical relays on the Control Cards are more noisy than the relays during Punch-in in Auto mode.

1. K1 replacement card PCA9000B0124-00A (mounted on each Control Card)

Clip out C1

Change C3 from .1 mfd to 1.0 mfd 55v. (observe polarity)

SEE SKETCH BELOW

2. A few of these cards have a 2.2 mfd cap. (C2). This cap was deleted in later production. IF you are making the changes and IF the Card has a C2 (See sketch below) clip it out.

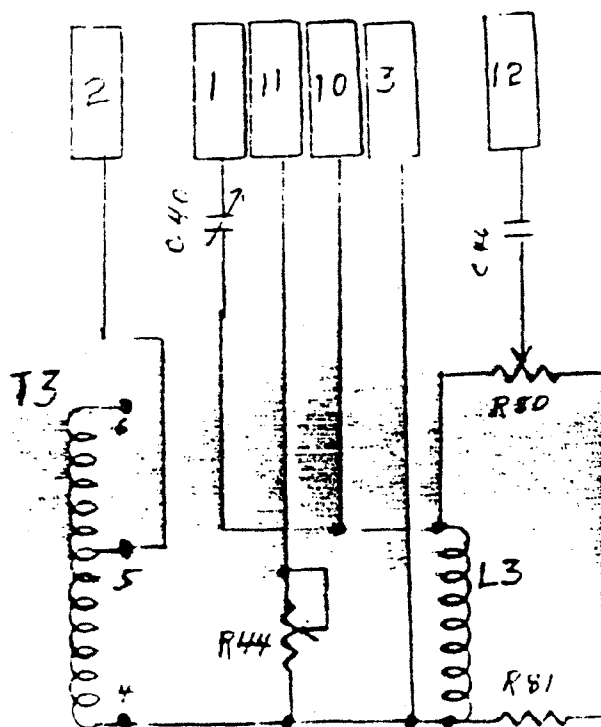
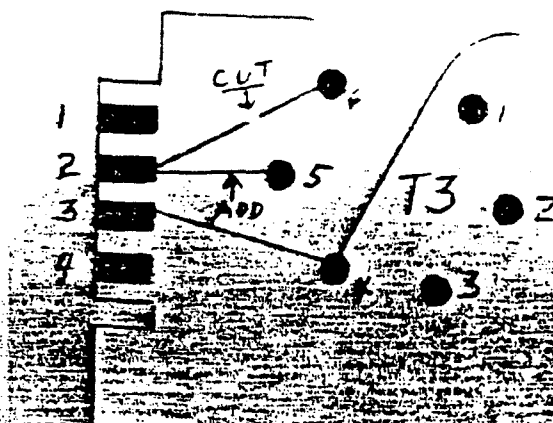
REASON FOR CHANGE: When using WOELKE ERASE HEADS, some interaction has been noted between channels. Also excessive adjustment has been needed when changing between 24 TRK and 16 TRK head assemblies.

DESCRIPTION OF CHANGE: SEE THE SKETCH BELOW

1. Cut the land between Pin 6 of T3 and Pin 2 of the edge connector.
2. Add a bus wire from Pin 5 of T3 to Pin 2 of the edge connector.
3. Change R81 from 1 k $\Omega$  to 240 $\Omega$ .

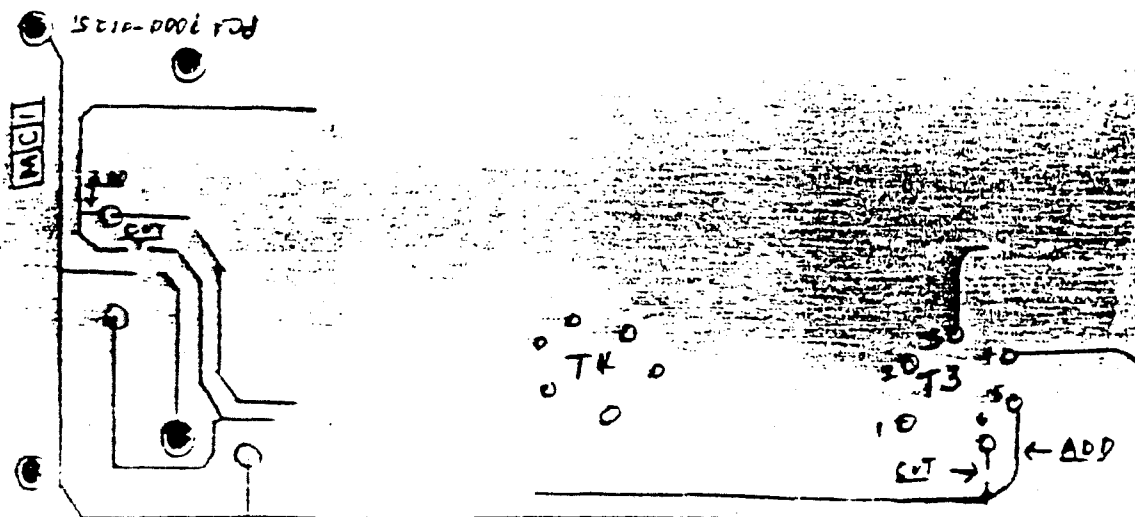
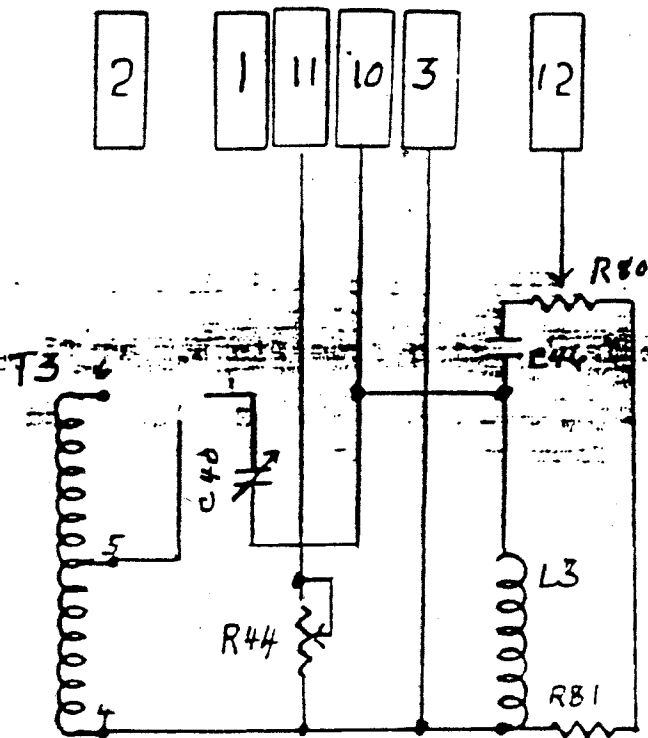
REASON FOR CHANGE: When using WOELKE ERASE HEADS, some interaction has been noted between channels. Also excessive adjustment has been needed when changing between 24 TRK and 16 TRK head assemblies.

DESCRIPTION OF CHANGE: SEE THE SKETCH BELOW and SCHEMATIC on next page

1. Remove C47, replace with bus wire.
2. Cut the land between C47 and C40 (trimmer)
3. Connect the output side of C40 (connects to Pin 10 of the edge connector) to the land which formerly came from C47.
4. Cut the land coming from Pin 6, at T3. This land goes to C40.
5. Install a bus wire from Pin 5, T3 to the land cut in the step above. (Connects T3, Pin 5 to C40).
6. Change R83 from 100 $\Omega$  to 47 $\Omega$ .
7. Change C42 from .01 $\mu$ f to .012 $\mu$ f.

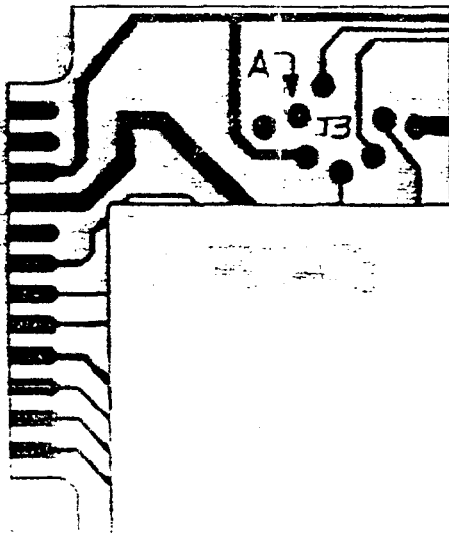
PCA 9000-0125

REASON FOR CHANGE: When using WOELKE ERASE HEADS, some interaction has been noted between channels. Also excessive adjustment has been needed when changing between 24 track and 16 track head assemblies.

Cut one lead and install one jumper on the circuit side of the board as shown below:

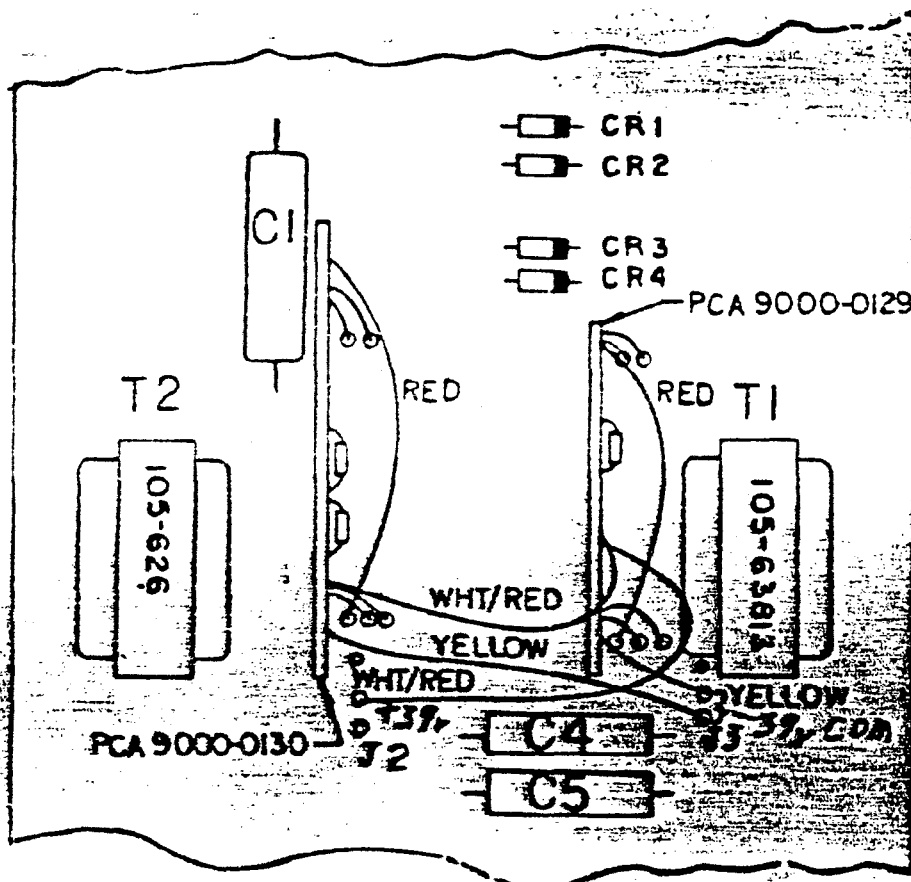
PC 9000C0005  
JH-10, JH-100

REASON FOR CHANGE: Sync relay switching noises can be eliminated by substituting FET switches for K1 and K2.

DESCRIPTION OF CHANGE: Remove K1, K2, and CR2. Remove J2 & J3 (The 3 pin Molex connectors nearest T1 & T2). Install PCA 9000-0129 and PCA 9000-0130 as shown by the sketch below.

CR2 must be removed to prevent feedback when doing OVERDUB in REMIX mode.

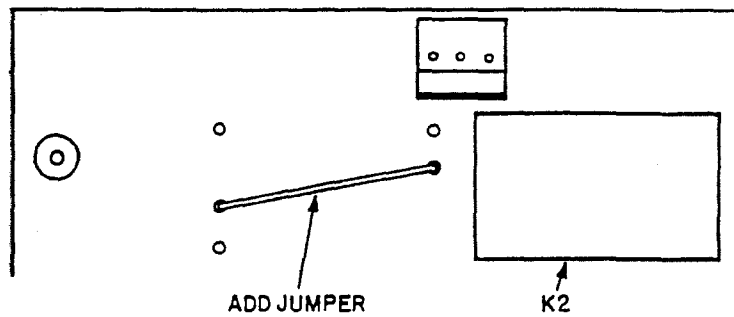
MCI  
#130

Eliminate switching noise of Sync Relay when in AUTO mode and channels are in Record Ready then switching transport from Play to Stop or Stop to Play.

Remove Relay K1 on Master Status Board and jumper common contact and normally open contact (see Illustration on reverse side).

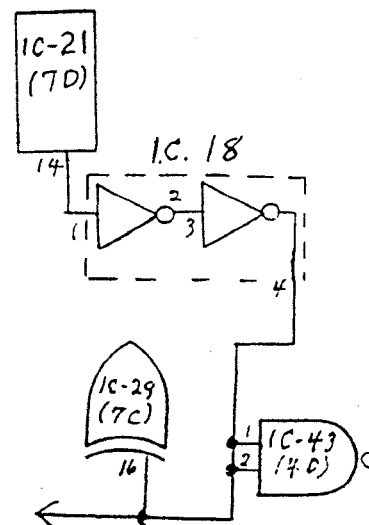
## SCHEMATIC CHANGES

The output of I.C. 21 was overloaded. This has resulted in the Subtractor working erratically. In some cases this I.C. has burned out.

- A. A Jumper from Pin 2 to Pin 3 of I.C. 18 (position 7E).
- B. A Jumper from Pin 1 of I.C.18 (7E) to Pin 4 of I.C.21(7D).
- C. A Jumper from Pin 4 of I.C.18(7E) to Pin 14 of I.C.29(7C).

This change makes use of two spare inverters (located in I.C. 18) to provide a buffer for the output line of I.C. 21.
